Observation of the internal change of grains in metals caused by cavitation impact

Shinobu Sugasawa^{1†}, Susumu Uematsu¹ and Shigeru Akiyama¹ (¹National Maritime Research Institute)

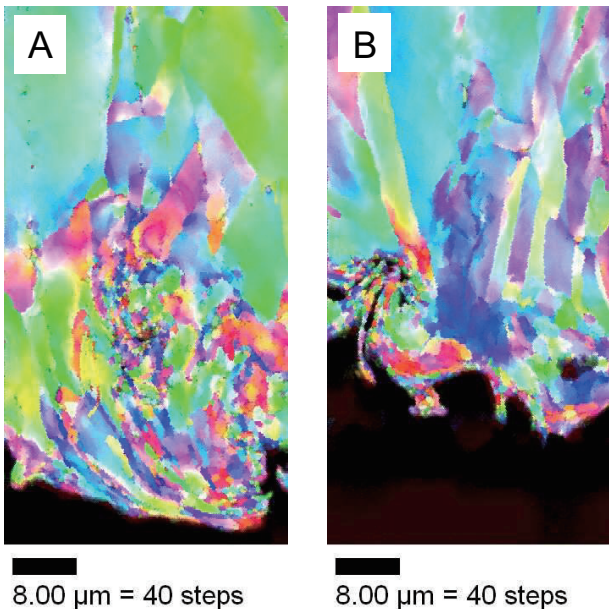
Fig. 2 EBSD image of tough-pitch copper.

In tough-pitch copper (Fig.2), not only grain refining but plastic deformation is remarkable. Grains of sub-micron order are also observed.
